RE: Sampling Inspection  
 Keystone Steel & Wire Co.  
 ILD 000 714 881

RFA SAMPLING VISIT - KEYSTONE STEEL AND WIRE, PEORIA, ILLINOIS  
ILD000714881  
DECEMBER 8, 9, 1987

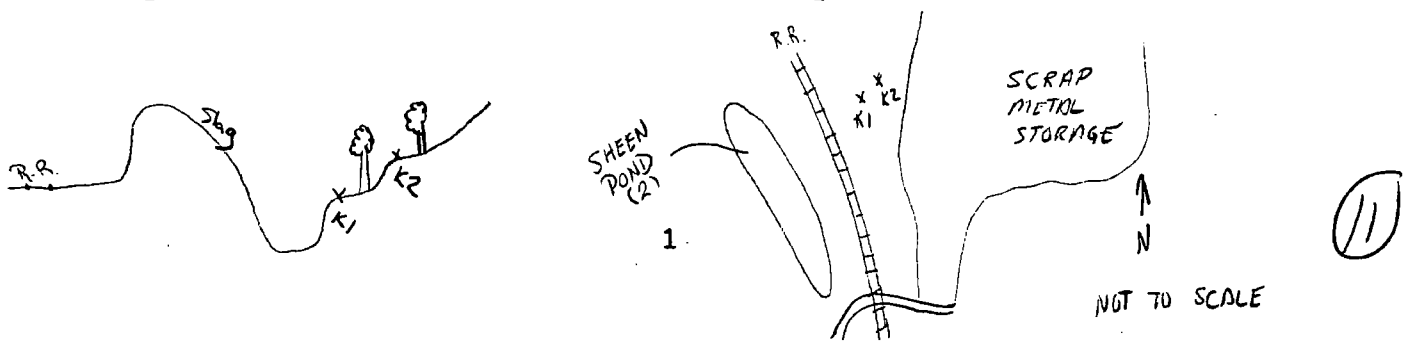
1) Background Samples

Upon examination of the aerial photos a wooded area east of the sheen pond was chosen for the background samples. The west edge of this wooded area was artificially built up with slag and large furnace slag blocks. However, as you trend north and east the area looked relatively undisturbed. The area is ravine-like. We avoided the bottom and collected two samples(K1,K2), one each on tiers going up the east side. Except for trees, which we could not reference exactly, there were no reference points from which to tape the exact locations of these samples.

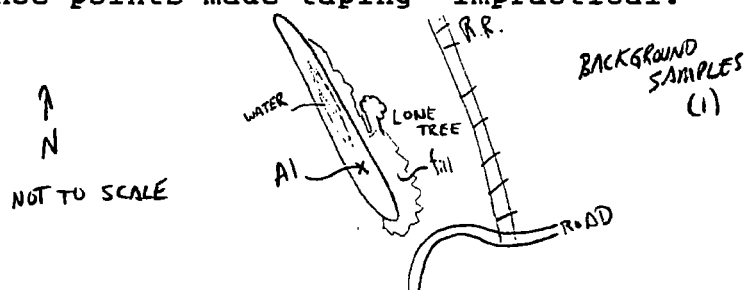
2) "SHEEN POND" - identified on the aerial photos as pond with a sheen. This area was very muddy due to the rains of the past several days. However, the pond did not collect/retain much water. No sheen was apparent on the water or sediment. Much more debris and fill material was piled around the pond as opposed to the VSI. Dale B. said the fill material was a result of railroad track work. I got the impression from Dale B. that this depression(pond) is to be filled. The sample (A1) came from the center of the pond about 1/3 north from the south end. An exact location was not determined. The lack of any good reference points made taping impractical.

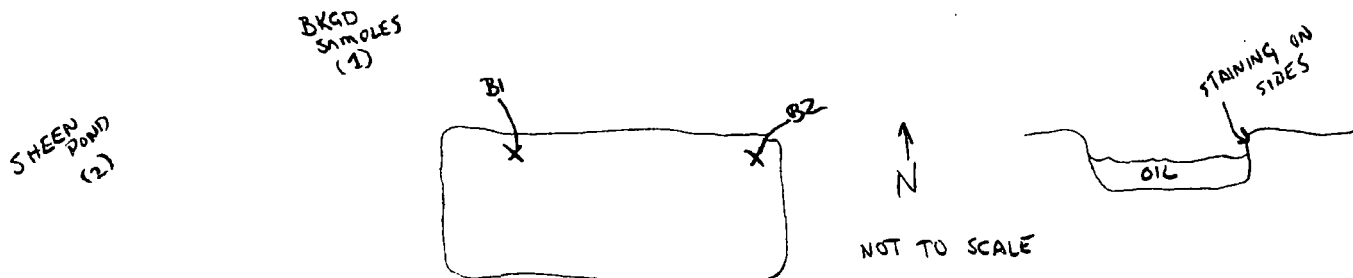
3) "OIL POND" - identified as a sludge pond on the aerial photos. Upon examination, the pond looked to be filled with an "oil" about the consistency of used motor oil. A sediment sample (B1) was collected from the north side towards the northwest corner. A ladle attached to a pole was used to collect the sample. The bottom sediment had the consistency of sludge. No reading was registered on the Hnu, although an odor could be detected. A liquid sample (B2) was also collected, taken from the Northeast corner. This sample confirmed my suspicions; that the pond is filled nearly entirely with oil, and is not simply an oil film. I observed oily water running across a road from a scrap metal storage area to the pond. While this may help explain some of the oil in the pond, I don't think it can account for the quantity and consistency of the oil in the pond. I advised Dale B. to try to find out the source of the oil in the pond, as this pond could be called impoundment.

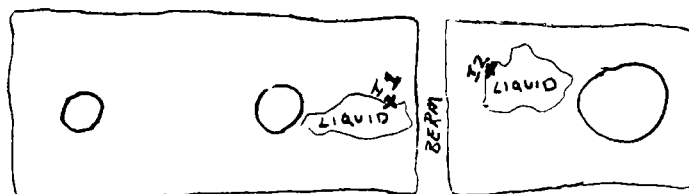
4) Vertical tanks - Much more liquid was present in the tank bermed area than during the VSI. The recent rains do not seem able to explain this entirely as the liquid appeared more oily also. Heavy staining was also very apparent. Two samples were

taken (I1,I2), one from each area, each near the liquid soil border. Sample I2 was taken between 2-5" depth.

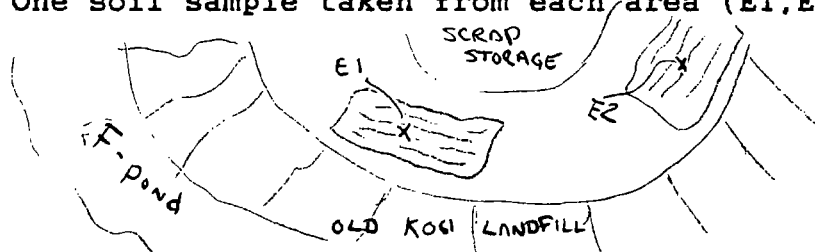
6) "LAND TREATMENT" - Area atop old K061 landfill. Two areas were "freshly" disked, and land treatment machinery was also present. Areas disked seemed larger than observed during the VSI. One soil sample taken from each area (E1,E2).

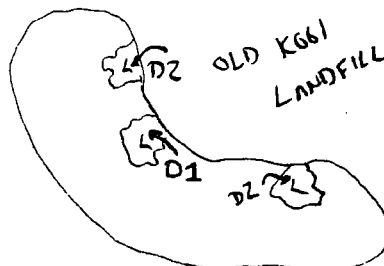
7) F-POND - Pond to the south and west of the old K061 landfill. An obvious white leachate/precipitate was present in at least three locations in the pond. A sediment sample was collected from one location (D1) and water samples were collected near the other two (D2,D3). Dale B. said he believes the white sediment is a lime leachate originating from the old landfill. He also stated that other materials, besides K061, were also placed in the landfill. I was not aware of this and I am not sure if anyone else is either.

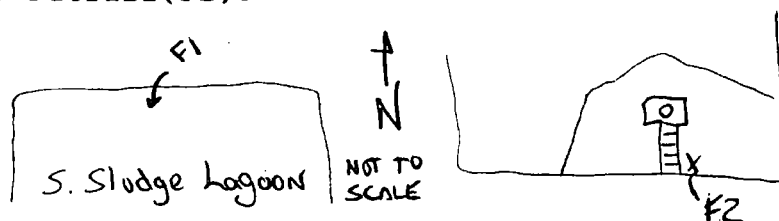
8) Sludge Lagoons - Took a surface sediment sample from the south

lagoon(F1), and a water sample from the North(active) lagoon near the outfall(F2).

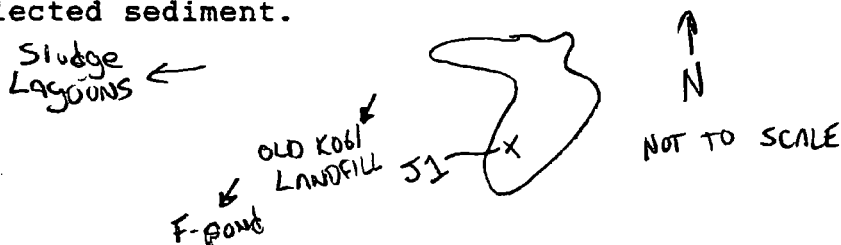
9) Pond - This pond is east of the Old K061 landfill and north near the canal. The pond exhibited an uncharacteristic lime green bottom sediment color. A surface sediment sample (J1) was taken near the southwest corner. Traces of oil were present in the collected sediment.

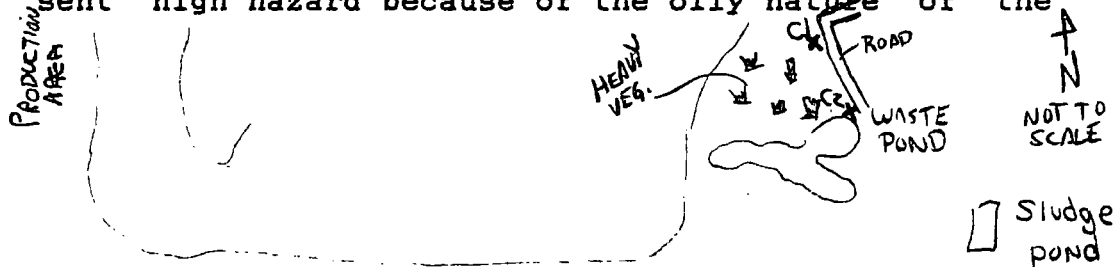
10) Cooling Pond - This pond east of the production area is used as "non-contact" cooling process water. The aerial photos identified a sheen on the water in a canal on the west side of the pond. As during the VSI no sheen was apparent in this canal area. On the east side however, an oily/rusty film, as noted during the VSI, is trapped in some heavy vegetation. This time the film appeared much more oily, with less of the rusty film. A white "flaky" substance was also floating on the surface. Two water samples were taken (C1 & C2). The south sample was much more oily. Ken Kreuger, of Metcalf & Eddy decided these samples should be sent high hazard because of the oily nature of the samples.

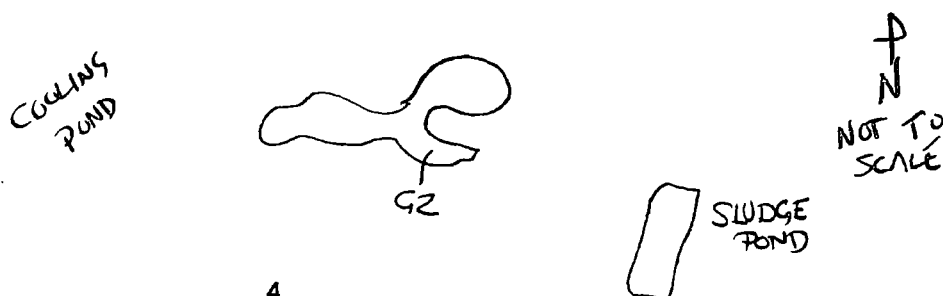
11) Waste Pond - Pond just east of the cooling pond and west of the sludge pond. A water sample was collected from this location (G2), from the southeast corner. A white sediment is present in this pond. The objective was to sample the water to see if the water is contributing to, or the source of, the white precipitate.

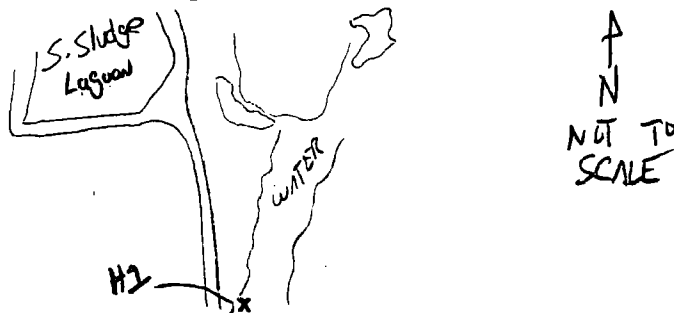
12) "MUD LAKE" - Prior to the construction of the WWTP Keystone channeled their K062 waste to the Illinois River via this "mud lake" region. Unfortunately, nobody is quite sure, or willing to admit to, the location of this area. All I know is that the area is south of the location of the present day sludge lagoons. A water sample (H1) was taken from this area, about 2000' down an sandy road leading south from the east edge of the south lagoon. During the VSI I saw an oil film on the water in this area. However, there was none apparent during the sampling visit. This area is/was used quite extensively for duck hunting, including the use of several boats, and was active during the VSI. It is possible that the oil film originated from this boat traffic. The hunting season is supposedly over and the oil film is no longer visible, so it may have been of motorboat origin.
